UST PHOTOGRAPHIC LOG

Facility Location: Sac & Fox Truck Stop, 1346 HWY 75, Powhattan, Kan.		Photographer: Michael L. Pomes	Camera: Canon Powershot SD 1300 IS, #092064146322
Dates Photographs Were Taken: 9/26/2013

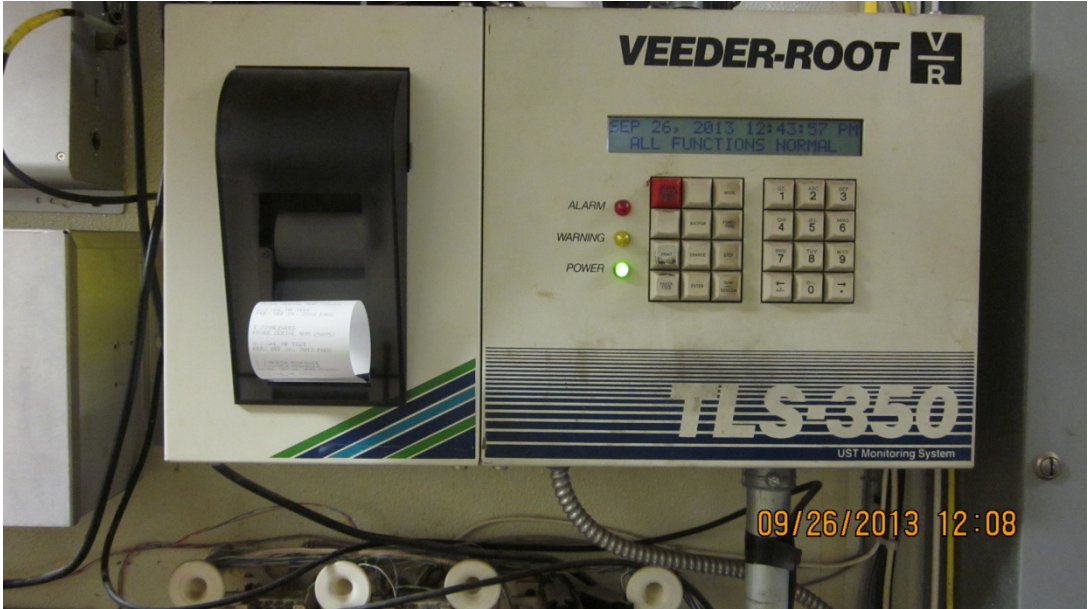
Photo No. 1	Time: 1208		
Direction Photo Taken: Inside			
Photo Description: Operational Veeder Root TLS-350 ATG.

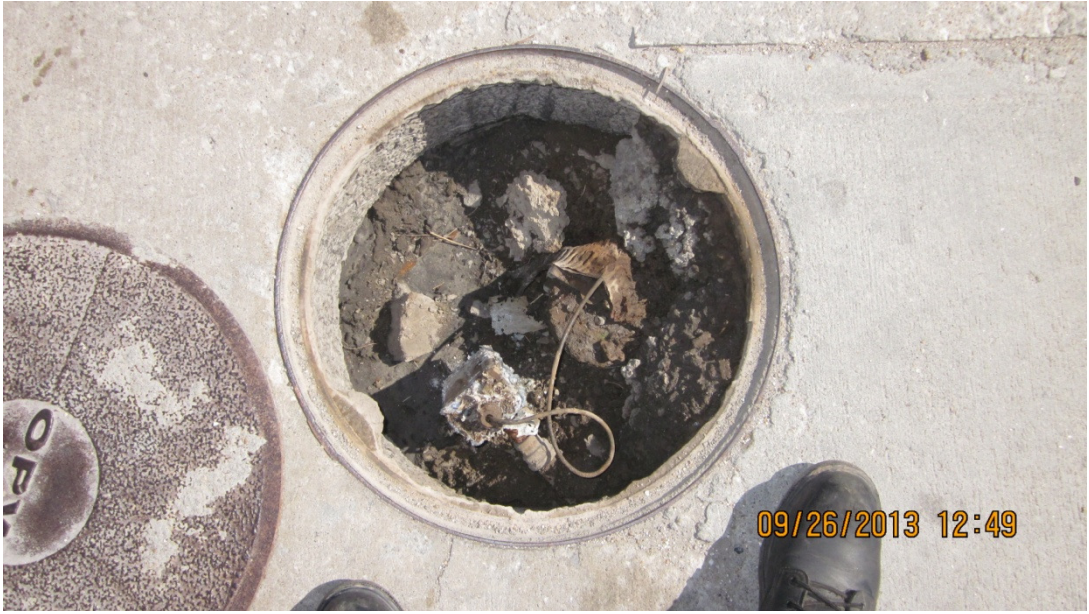
Photo No. 5	Time: 1249	
Direction Photo Taken: Down		
Photo Description: North Midgrade (Tank 3) ATG probe.

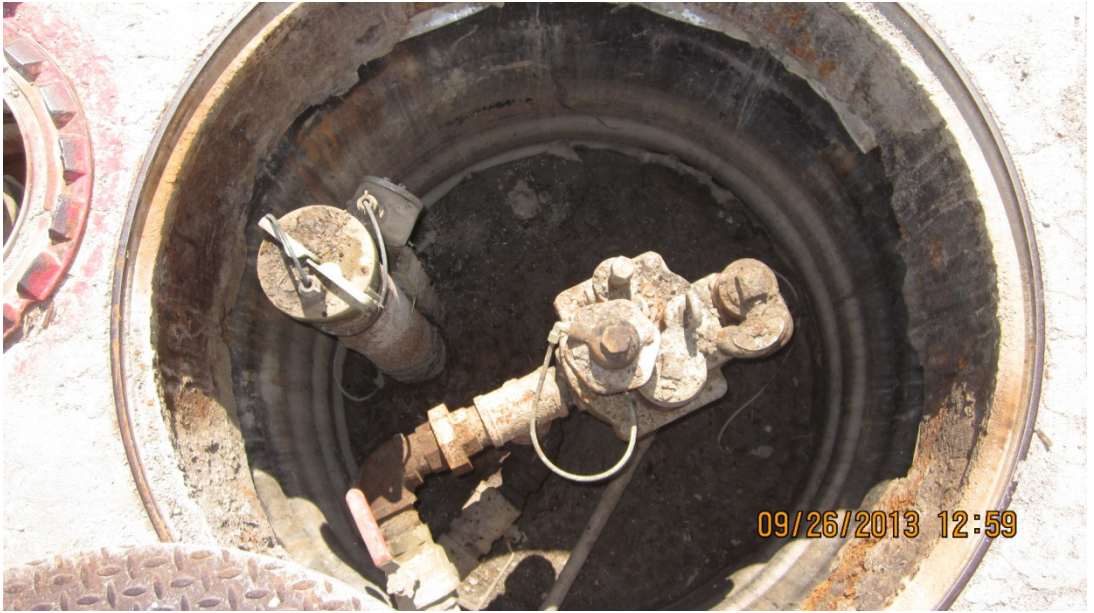
Photo No. 13	Time: 1259	
Direction Photo Taken: Down		
Photo Description: Premium (Tank 1) submersible pump sump and ATG probe. Veeder Root FX1V MLD used for pressure lines leak detection.
